# ALAMO CITY HOME INSPECTIONS +12105570944 alamocityhomeinspections@gmail.com

# HOME INSPECTION REPORT

13231 Lorena Ochoa San Antonio, TX 78221

# **PROPERTY INSPECTION REPORT FORM**

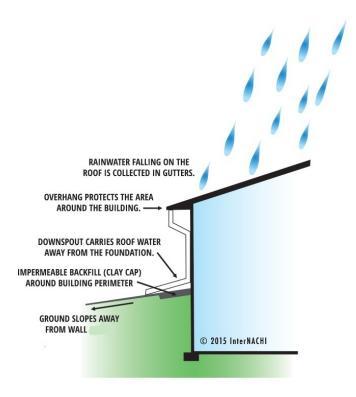
### No Gutters:

The home had no roof drainage system to channel roof drainage away from the foundation. Elevated moisture levels in the soil near the foundation can affect the ability of the soil to support the weight of the structure above and can cause problems related to soil/foundation movement. The Inspector recommends the installation of a roof drainage system to help protect the home structure.

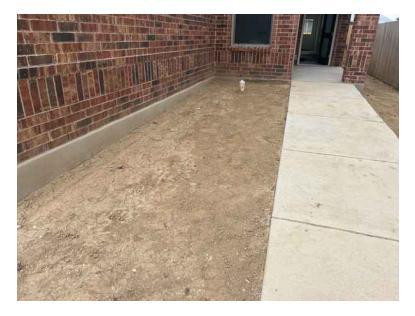
Although there is not the proper 6" drop within 10' of the slab around certain areas of the structure. Indications are that the water is flowing away from the structure and no immediate issues were noted, recommend monitoring and correcting the slope as needed.

Recommendation: Contact a qualified grading contractor.

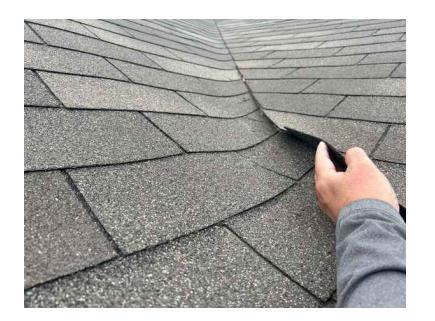
Manually seal closed cut valley :

Recommend Manuel ceiling of shingles in the closed cut valley to prevent wind blow off. The shingles lift easily as there is no adhesive in this location.

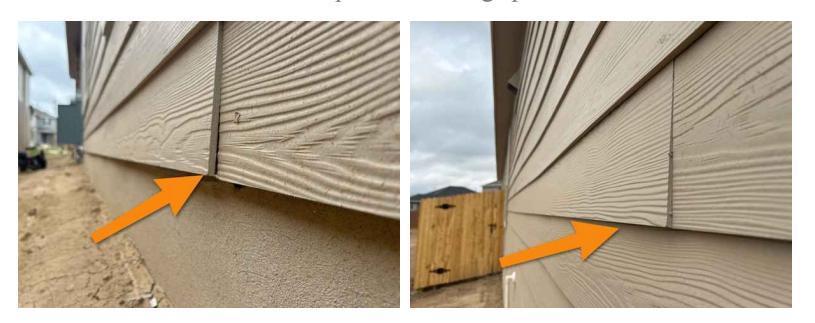
The exterior siding was loose the home. Recommend all loose siding be refastened.

Recommendation: Contact a qualified siding specialist.

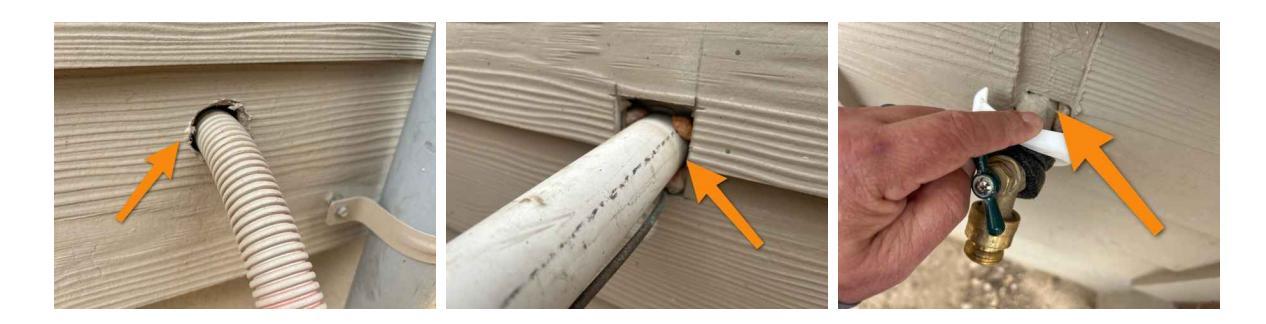
**2:** Seal gaps and holes in the siding Orange

Seal all gaps and holes in brick or siding to help prevent moisture intrusion.

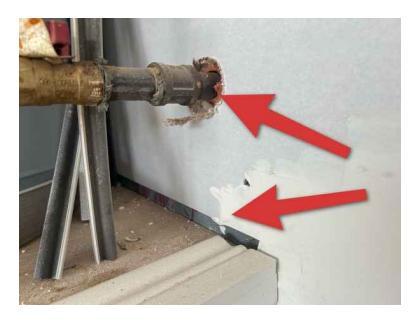
# **3: Hole in wall of garage** A Red

There is a hole in the wall in the garage. All holes in the garage walls adjoining the living spaces should be patched to help keep the recommended fire barrier between the home and garage.

Recommendation: Contact a qualified drywall contractor.

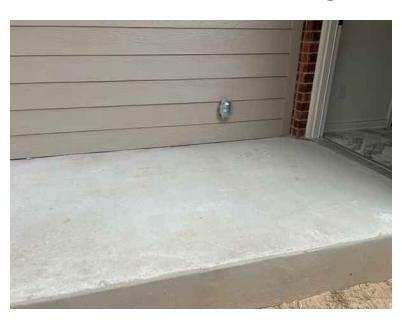
### 4: Siding clearance Orange

A clearance of 2 inches must be maintained between siding and trim products where they meet roofs, decks, paths, steps, driveways or any other solid surfaces. The front patio was designed to meet ADA requirements and the area was covered. We make no recommendations for repairs in this area.

Recommendation: Contact a qualified siding specialist.

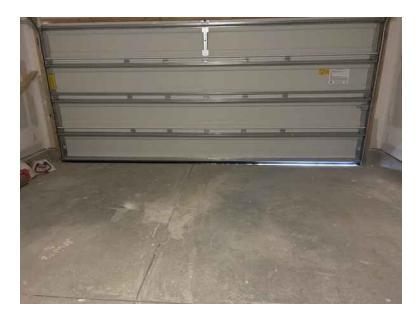
### Garage door uneven contact:

The garage door makes uneven contact with concrete allowing daylight to enter. The garage door opener may alleviate this problem once installed by applying pressure in the closed position thus closing off the gap.

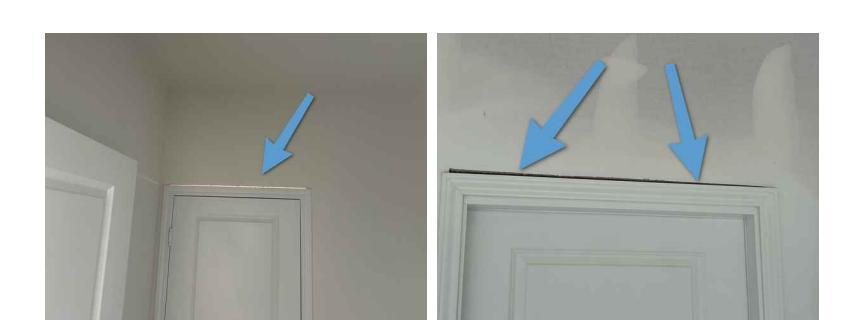
## 1: Air Gap Blue Garage

Air leakage was apparent at the time of the inspection. Methods used to prevent air leakage at doors typically include the installation of air sealant strips around door jambs and the installation of sweeps (a sweep is a rubber strip that attaches to the bottom of a door to seal the gap between the bottom of the door and the threshold). Homes without effective seals against air leakage at doors will incur higher annual heating/cooling costs and occupants may experience lower comfort levels than with a similar home with doors effectively weather-sealed. The Inspector recommends the replacement/installation of effective weather-stripping components as necessary.

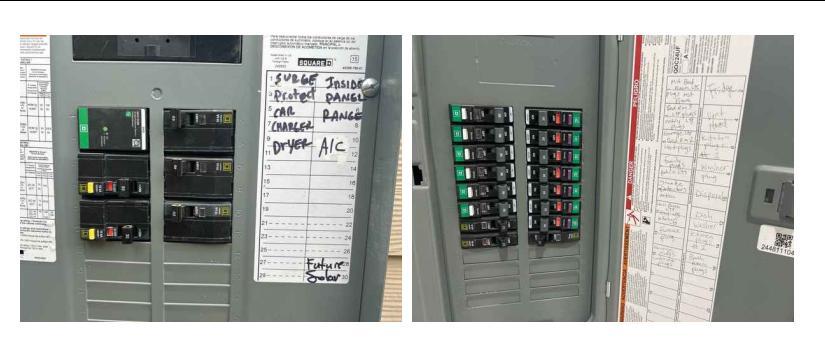
I observed a breaker in the "off" position prior to inspecting the electrical panel. Recommend asking the homeowner what this breaker is connected to, and why it is off.

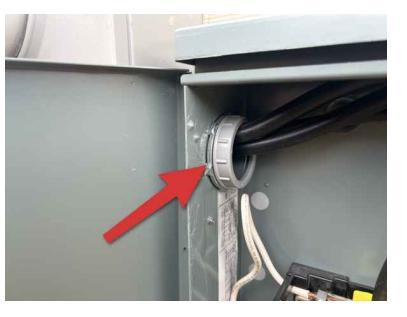
# 1: Bonding Clamp

There was no bonding clamp on the metal conduit between the meter and the panel.

Recommendation: Contact a qualified electrical contractor.

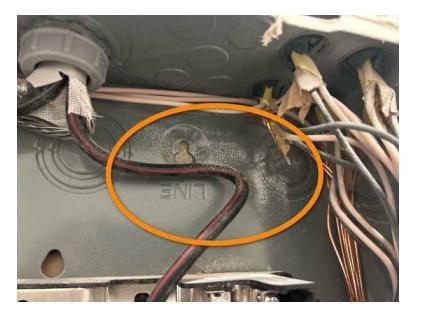
## 2: Paint/texture Orange

The interior of the panel was contaminated with paint/texture overspray.

Recommendation: Contact a qualified electrical contractor.

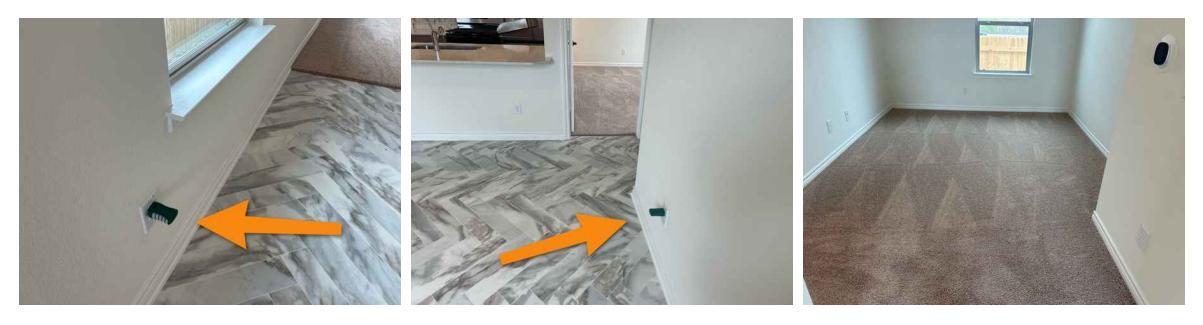
The test indicates an open circuit, no power. The dining area and common area outlets did not have power. This condition should be corrected by a qualified electrical contractor.

Recommendation: Contact a qualified electrical contractor.

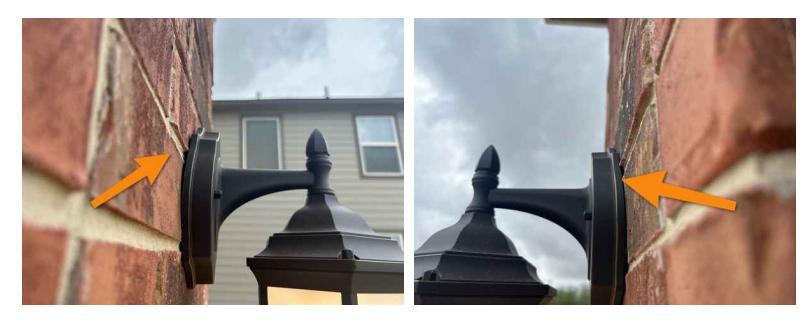
# 2: Seal exterior light

The exterior light was not sealed at the box and/or wall, recommend sealing to help prevent water entry into the box or wall.

Recommendation: Contact a qualified professional.

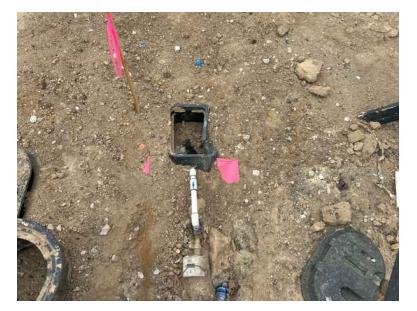
The water meter enclosure was not installed and the pressure regulator enclosure was full of soil. Recommend removing the soil to fully expose the water meter and main shutoff valve.

Recommendation: Contact a qualified professional.

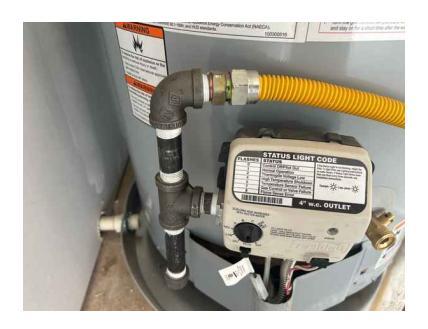
## White thread tape :

White thread tape was used on gas lines. Yellow thread tape is supposed to be used on gas lines while white thread tape is meant to be used onwater lines.

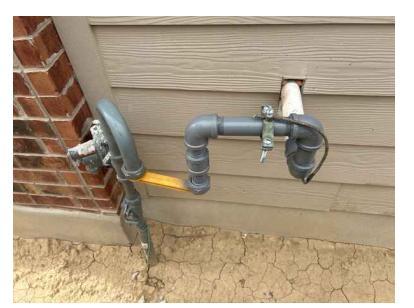
No Gas Meter:

The gas meter was not installed at the time of the inspection.

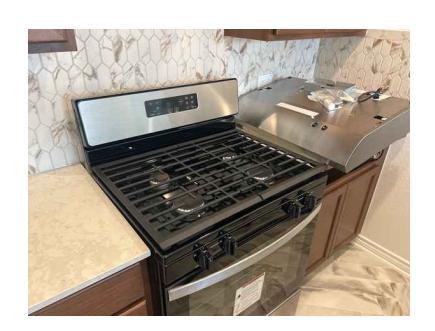
Range/Cook Top/Oven Energy Source: Gas Not fully installed : The oven/range combo was not fully installed as there was no power to this unit. The system could not be tested.

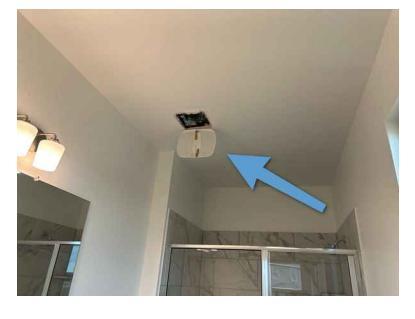
The bath or laundry exhaust fan cover is loose to the ceiling.

Recommendation: Contact a qualified professional.
